TP 185E  
Issue 4/2006

# AVIATION SAFETY LETTER

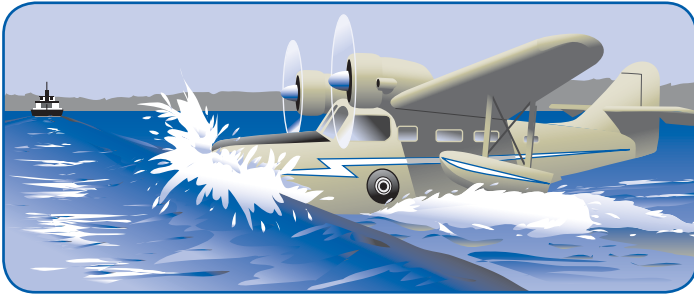
*Artist's impression of aircraft landing on bow wake*

— On March 24, 2006, a **Grumman Goose G-21A** was damaged on landing in Hardy Bay, Port Hardy, B.C. The aircraft had landed in a large bow wake created by a boat. The operator grounded the aircraft after maintenance identified upper wrinkles in the skin above the front windows and bent engine mounts. *TSB Report A06P0044.*

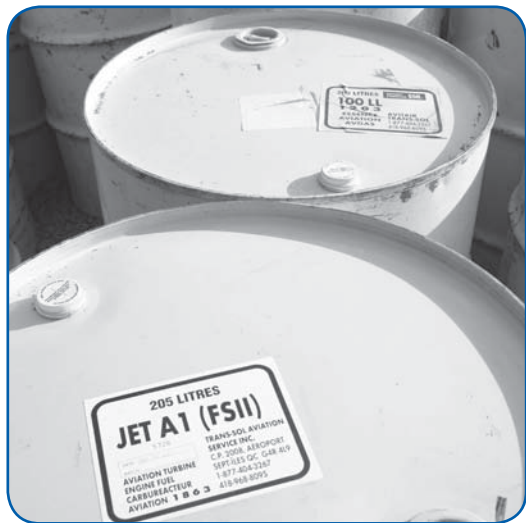
Photo 2: View of fuel barrel labels

The barrels delivered were all white, and all identifying stickers were also white. The identifying stickers included all the necessary information, as specified by provincial

regulations. The only difference between the two products was the words “100LL Avgas” and “Jet A fuel.” (See photos 1 and 2 taken on site.)

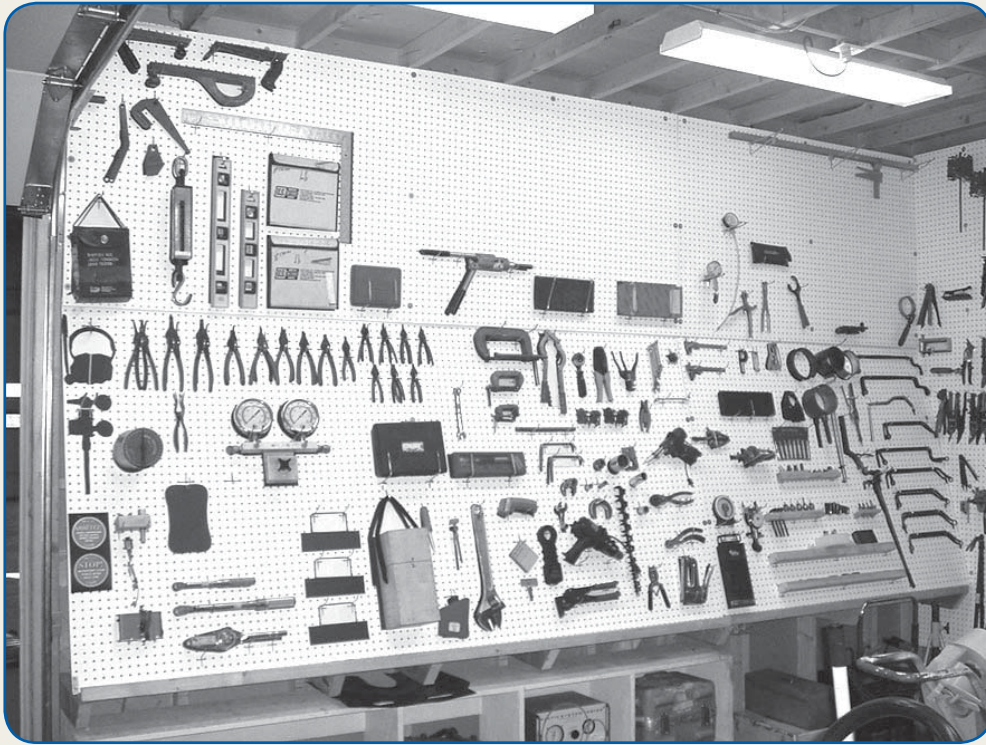
*A meticulously maintained tool control board enhances safety*

The picture above shows an example of a well-executed tool management system, or tool control board, in an aircraft maintenance engineer's (AME) shop on the east coast. The Regional Aviation Safety Officer—Maintenance in Moncton, N.B., Mr. Norbert Belliveau, reports that, “since we introduced the *Aviation Maintenance Tool Management* CD-ROM, many more AMEs and pilot-owners have undertaken to improve their tool control significantly.”

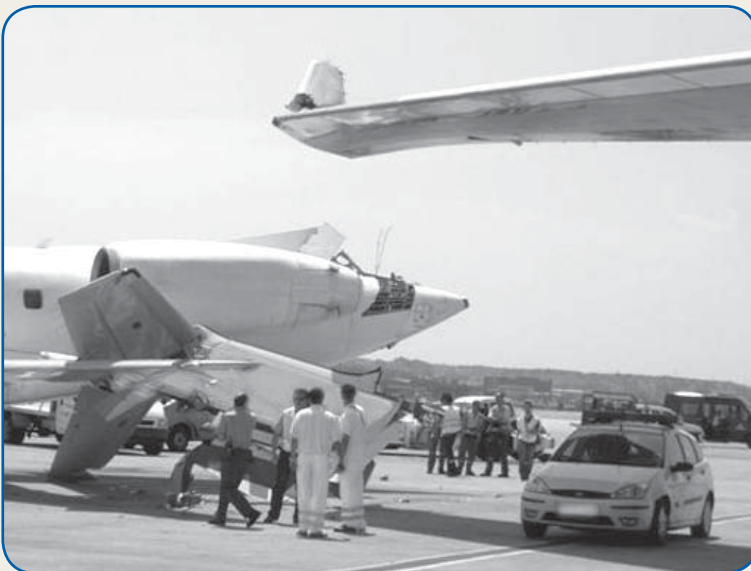
The photo on the left shows the result of a spectacular ground collision on July 15, 2006 in Madrid, Spain. The wingtip of a taxiing Boeing 747-400 sliced clean the T-tail of a stationary Embraer 145 jet. Fortunately there were no injuries, but there was significant stress for all involved.

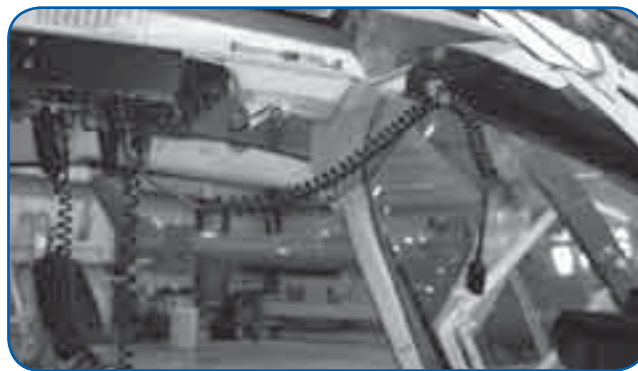
Figure 2. Intermediate helmet “pig tail” connection cords

In the past, similar BO-105 helicopters have been fitted with an intermediate “pig-tail” communication cord for helmet connections. Instead of plugging the helmet cord into the helicopter's receptacle, the helmet cord is instead plugged into this intermediate cord (see Figure 2).

The helmet connection plug can release cleanly from the intermediate “pig-tail” cord receptacle as it is pulled in the direction of travel during egress. Over a period of years, the use of the intermediate helmet cords at this operator declined, perhaps because pilots were not aware that the cords ensure separation in an emergency. However, since this accident, the operator has indicated that the use of intermediate “pig-tail” cords for helmet connections will now be re-instituted where necessary.
